(6) National Dam Safety Program, George B. Stevenson Dam (Inventory Number PA-914), Susquehanna River Basin, First Fork Sinnemahoning Creek, Cameron County, Pennsylvania. Phase I Inspection Report.

GEORGE B. STEVENSON DAM

INVENTORY NUMBER PA-914

PHASE I INSPECTION REPORT

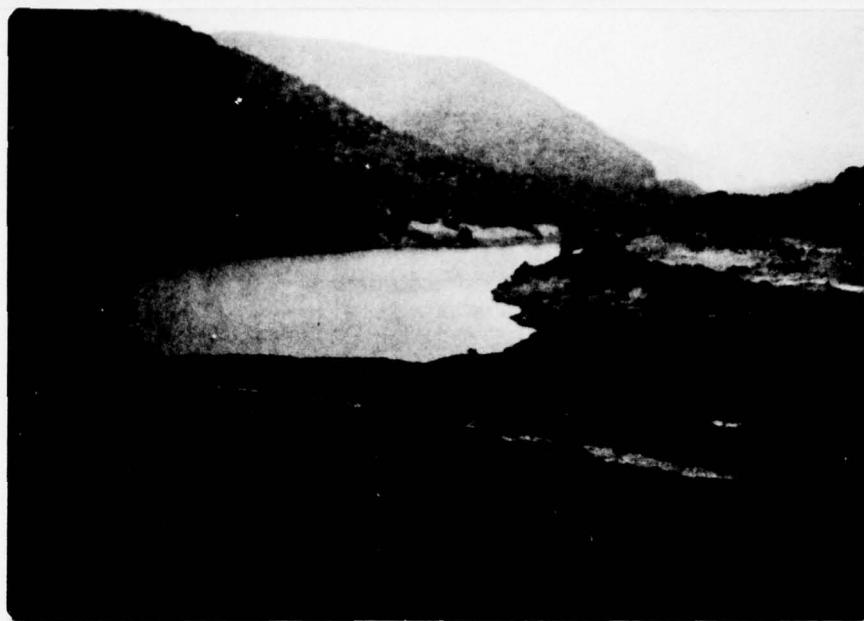
Reservoir and
Trash Boom

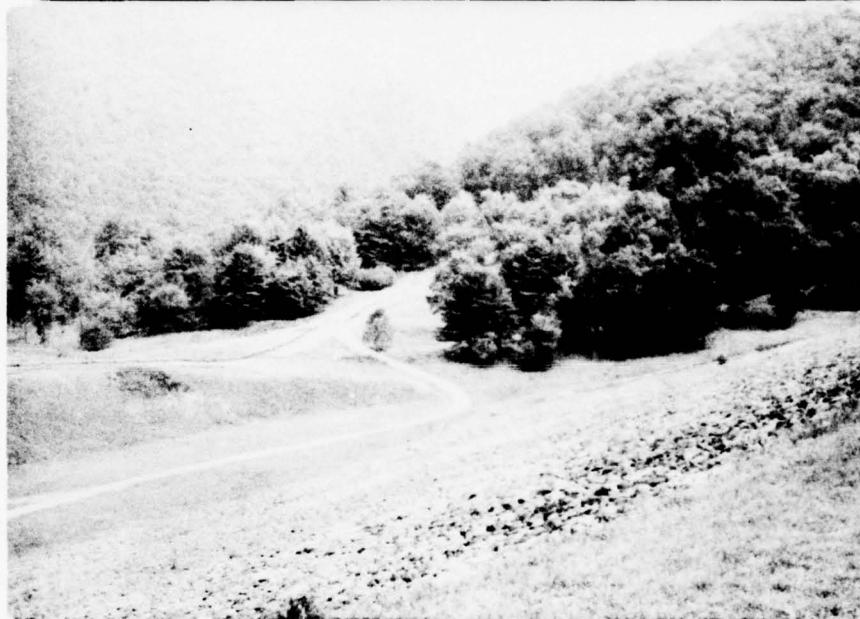
At the time of inspection the pool level was at elevation 920.5 and the full upstream side was exposed, except the toe which was used as a cofferdam during construction. The stone slope was in excellent condition. The top of the dam has a gravel roadway and had a good horizontal and vertical alignment. The downstream slope and toe is grassed, mowed closely and gives a very well maintained appearance. At a few locations the slope undulates slightly, but this was apparently constructed that way. Several groundhog holes and mole holes were noticed.

Upstream Slope

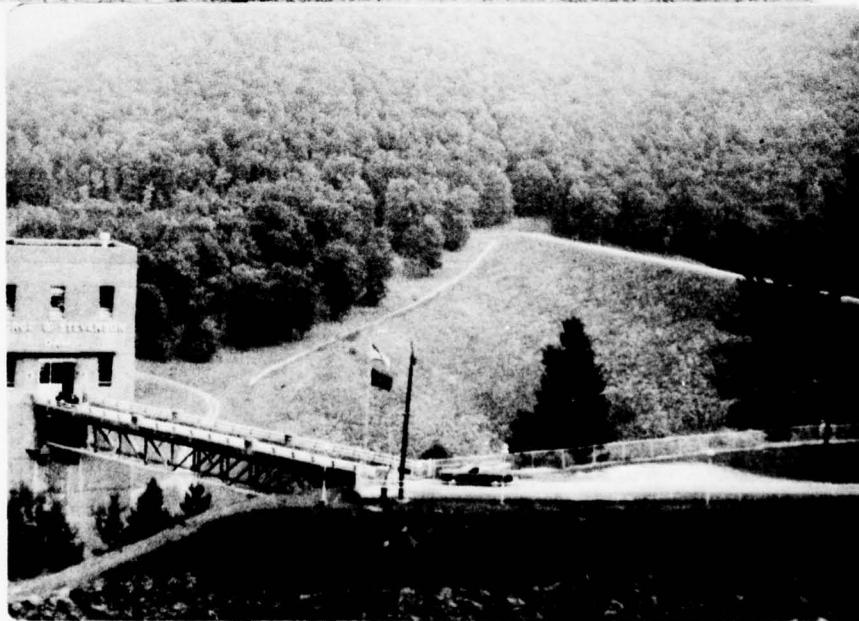
Upstream Slope
and
Intake Tower

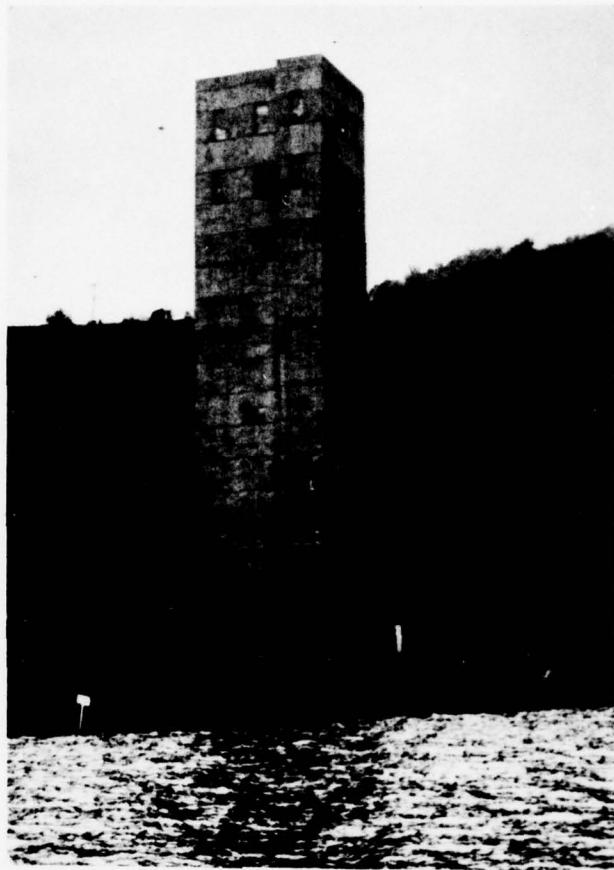
The intake structure was in good condition. The tractor type gates are pulled up once a year for maintenance after lowering an emergency close-off gate. The 8-feet by 16-feet gates are used regularly to maintain the conservation pool at elevation 920. They are used alternately on a monthly basis. The electrical hoist to open these gates is backed up with an L.P. gas generator.

Intake Tower and Trash Boom

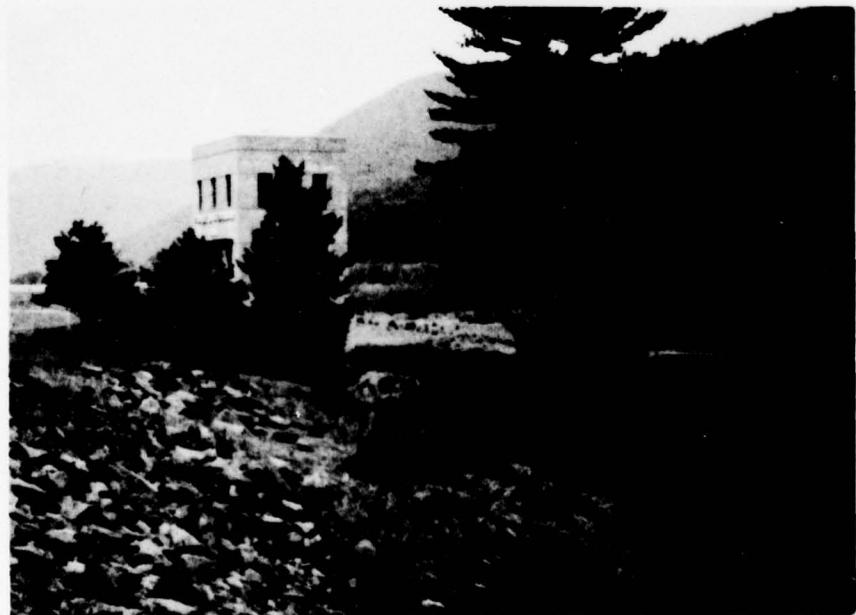
Reservoir and Tower

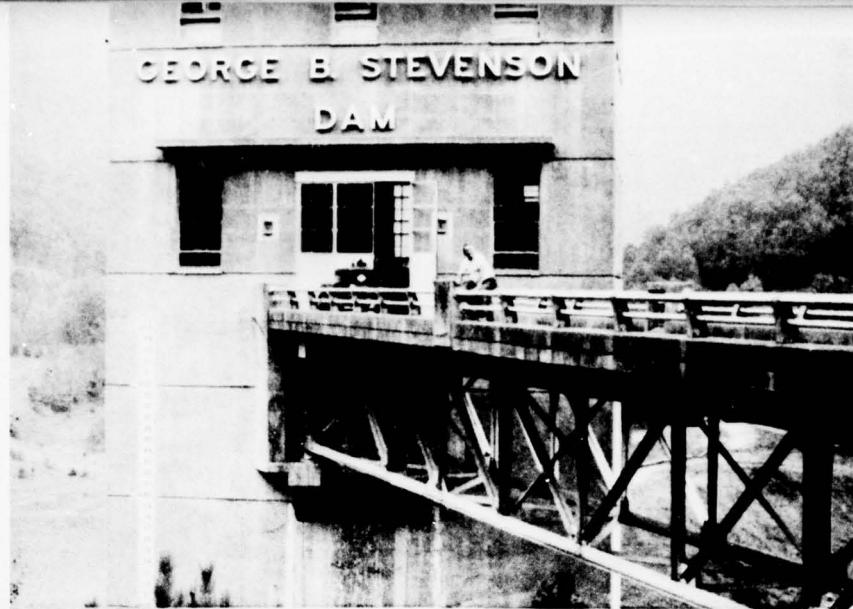
Access Bridge
to Tower

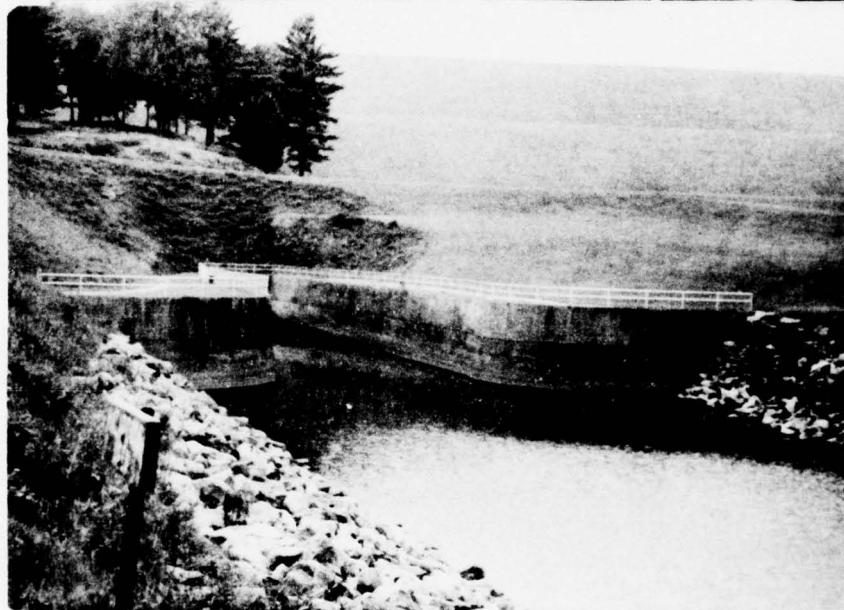
The water through the gates is discharged through a 16-feet diameter concrete lined tunnel, excavated through the hillside. The tunnel was in good condition. Only one small leak in the roof was noticed. The tunnel discharges in a tapered stilling basin with some energy dissipating blocks. The concrete of the stilling basin walls was in good condition and the downstream channel rock lining appeared to be stable. Some rock on the slopes had eroded during the tropical storm Agnes, but this has been repaired.

| <u>OUTLET WORKS</u> | <u>OBSERVATIONS</u> | <u>REMARKS & RECOMMENDATIONS</u> |
|---|---|---|
| B. OUTLET STRUCTURE | 16 feet diameter concrete culvert visible - refer to drawings. Concrete walls and bottom - flaring open from outlet and curved at the ends. Link fence around walls of outlet. One joint in roof leaks | |

Conduit Outlet

If the amount of leakage in the roof at one joint increases, it is recommended that the owner grout the rock strata in that area.

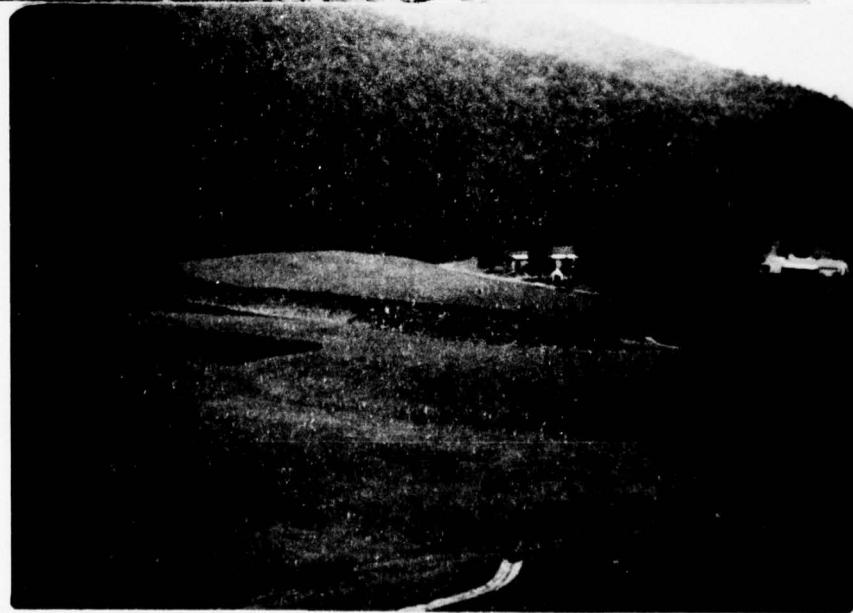
Outlet Channel

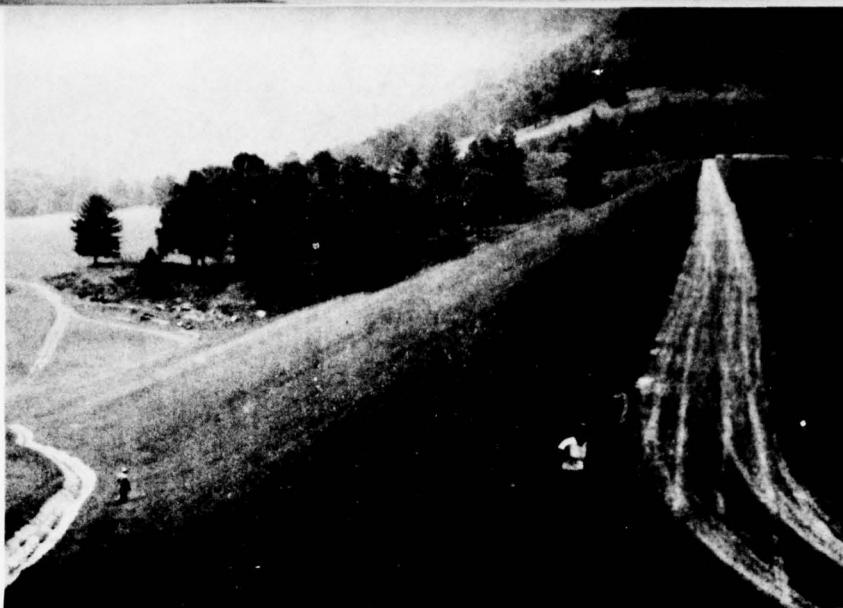
There are no visual indications of settlement or sloughing of the embankment slopes. The embankment is in excellent condition except the presence of some woodchuck holes on the downstream slope. It should be noted that the pool level at the time of inspection was 136 feet below top of dam and that critical seepage conditions could not be evaluated.

Downstream Slope
Looking West

1. Remove groundhogs and fill the holes in the embankment.

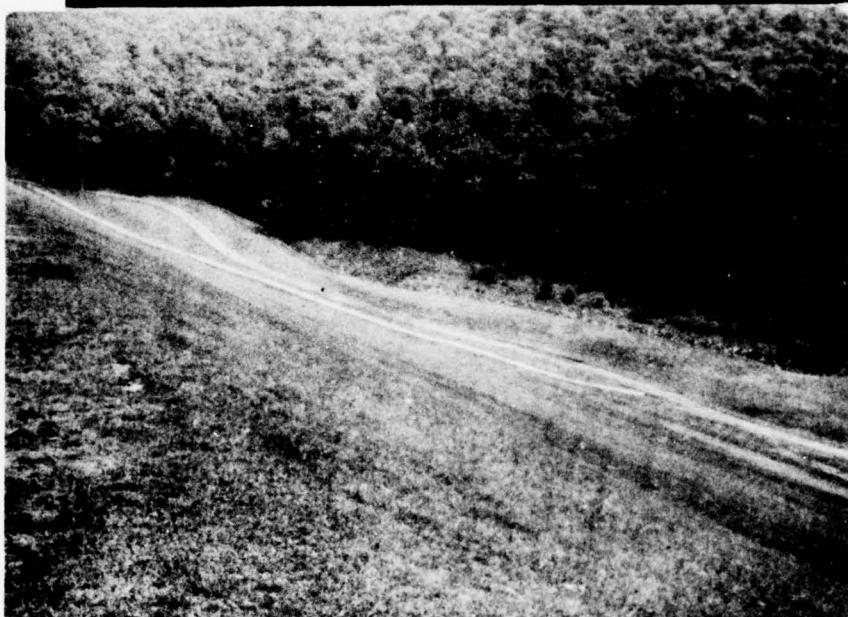
Downstream Slope
Looking East

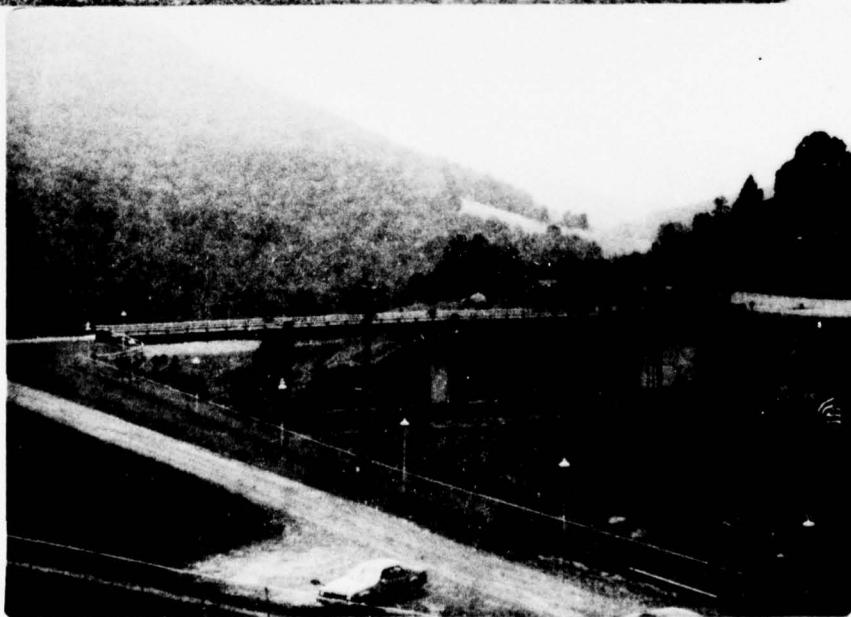
Forebay and
Spillway Bridge

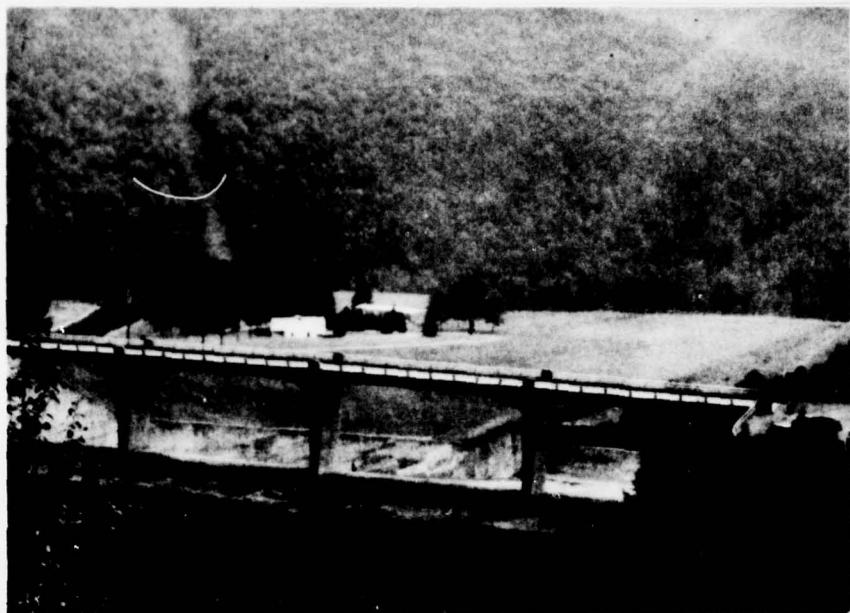
The spillway in the right abutment has never been tested. All concrete appeared to be in good condition and no wall movements were

The visual inspection of the spillway, spillway chute, intake structure, conduit and outlet works did indicate that all structures are in good condition. There was no excessive cracking, spalling or deflection in any of the structures.

Spillway

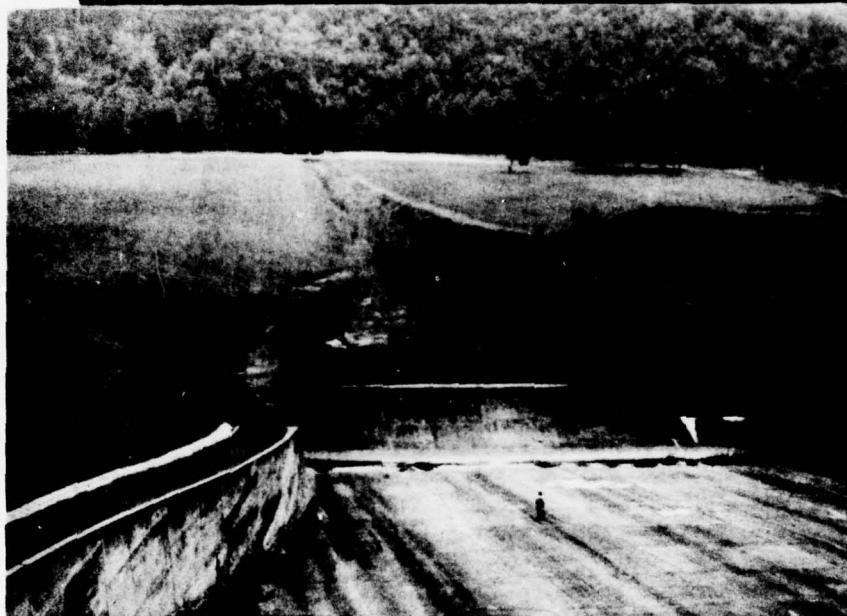
Spillway Flipbucket

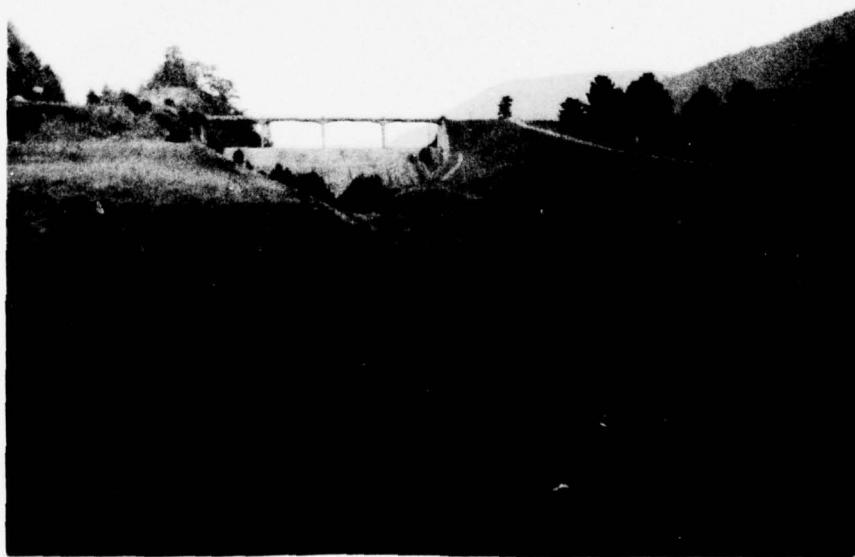
Except for a number of groundhog holes the dam and its appurtenant structure were in excellent maintenance condition. A considerable amount of downstream erosion can be expected if the spillway would discharge a large flow. This would, however, not endanger the safety of the structure.

used and downstream erosion can be expected when the pool level would raise above the weir elevation. The outlet channel had a maximum discharge of 8,000 cfs, and although some erosion occurred on the banks, no damage to the stilling basin was experienced.

Downstream
Spillway Channel
